Manhole Inspection Summary

Manhole # S41GG_036MH

Insp Date: **6/8/09 1:27 PM**

Location Address: **1431 PRESTON ST**

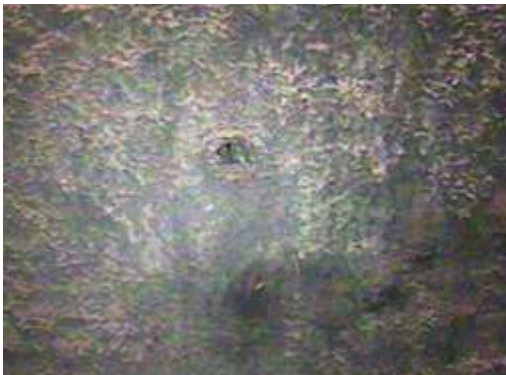
Comments **POSSIBLE ILLICIT CONNECTION - SEE PHOTO**

POSSIBLE ILLICIT CONNECTION

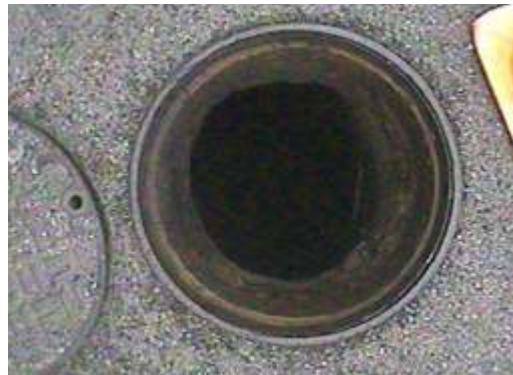
Defect 1

Offset: **1** (in.)

frame offset

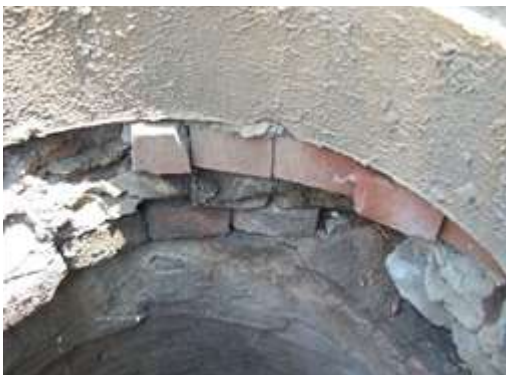
Defect 3

Condition: ☐ Sound ☐ Cracked ☐ Root Intrusion ☐ Loose Brick ☒ **Deteriorated**

deteriorated chimney

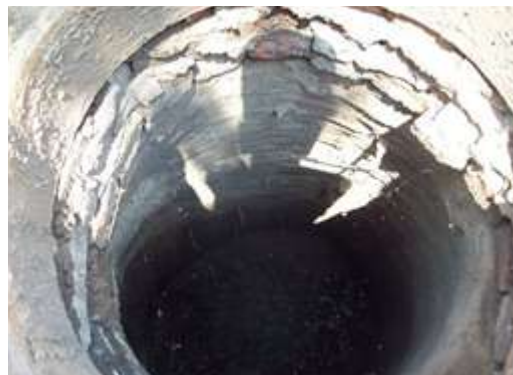
Defect 2

Count: **1** Missing: **4** ☒ **Corroded**

Corroded steps

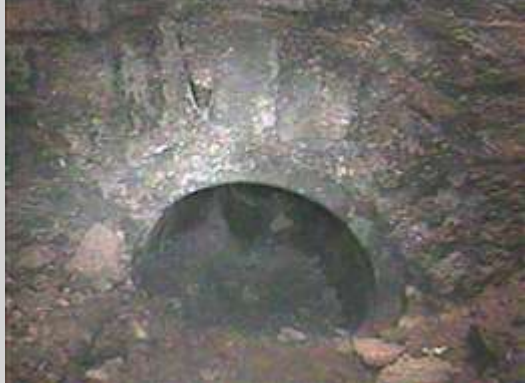
12 O'Clock Outflow

8 in. Circular Gravity Sewer
Pipe Out @ 12 O'Clock

Deposits: ☐ None ☐ Mud ☐ Sludge ☒ **Debris** ☐ Grease

Silt Depth: **2** (in.) Deposits Extent: **Light**
